INFORMATION BULLETIN

E Series Software v02.03 Upgrade

Applies to the Following Products	Prepared For
<ul style="list-style-type: none"> • DHD675-E • DWU675-E • DHD775-E • DWU775-E 	<ul style="list-style-type: none"> • External Customers • Christie Personnel

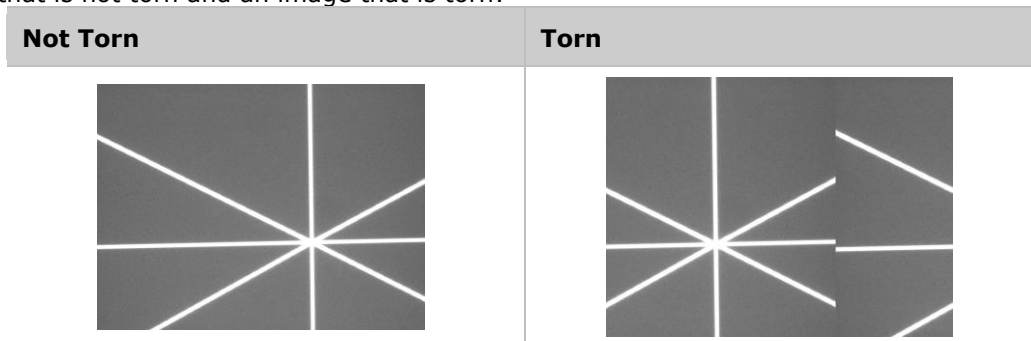
1. Resolved frame tearing seen in WUXGA units using HDMI inputs with the following signals: 1080P@24/25/30/50/60 Hz; 1080i@25/30 Hz; WUXGA@50/60 Hz.

Tearing is a term that references the shifting of an image. This can occur if the camera driver is confused about the image boundaries. The following table provide an example of an image that is not torn and an image that is torn:
