INFORMATION BULLETIN

Roadie Software Upgrade 1.9E

Applies to the Following Products	Prepared For
Roadie 25K	All Internal and External Customers
Roadie 25K LE	
Roadie HD+30K	
Roadie HD+35K

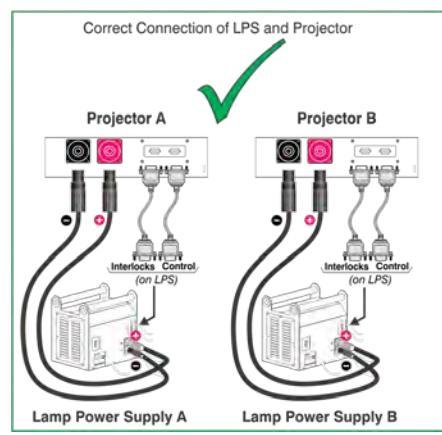
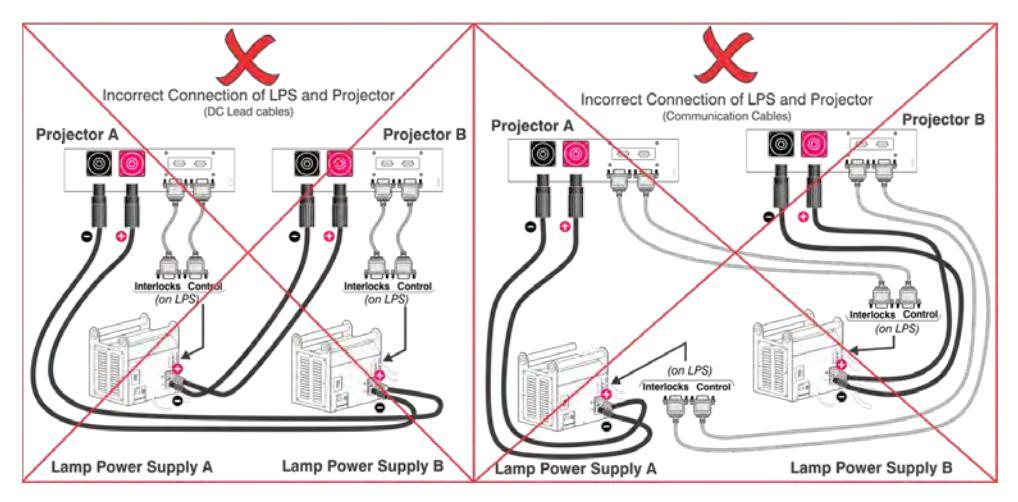
Christie was recently made aware of a situation in which a multi-projector installation was wired incorrectly. The DC leads of one lamp power supply were cross-connected to a second projector head but the interlock and control cables were not, causing a fire to ignite within the projector head.

Christie recommends that the units currently installed MUST NOT be operated until the installation has been verified as correctly connected. Use this diagram to determine if the connections between the projector head and LPS are correct:

To confirm that the cross-connection has not occurred, power only one LPS and projector pair at a time. DO NOT power multiple LPS and projector heads simultaneously. Before you turn on multiple projectors, you must confirm each projector head and lamp power supply are connected and operating correctly.
